**Flood Control Project Maintenance
Levee Inspections**

Maintenance Issue Types Only, Levee Inspection Report By Mile - Fall 2016

Lower San Joaquin Levee District

Waterway	Bank	Unit Miles	Inspection Start/End	Inspector
Unit No. 01 San Joaquin River	Right	22.52	10/17/2016 10/20/2016	Richard Willoughby

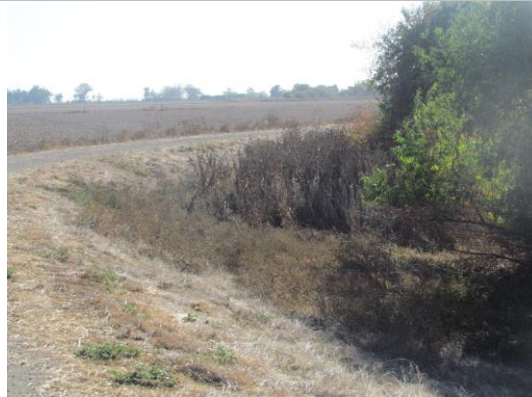
Photo 1 of 2 : FA_2016_NA0010_118_94_20161024_00236.jpg

LM Start	9.03	Rating **	U	Issue No.	94
LM End	9.72	Issue Type +	Ma	Location *	WS
Category	Earthen Levee			GPS Latitude/Longitude	
				Start	End
Item	Vegetation			37.297380°	37.293801°
				-120.850388°	-120.839759°
DWR ID	DWR_NA0010_01_f_2015_94				
Comment Code					
V2 : Remove the wild growth other than native grasses from the levee slopes.					
Inspector Comment

Looking south at dense veg on waterward slope. (Fall 2016)

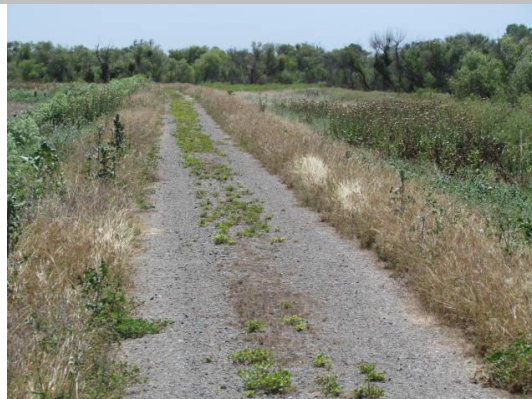
Photo 2 of 2 : FA_2016_NA0010_118_94_20161007_00019.jpg

Looking southwest at dense veg on waterward slope. (Spring 2016)

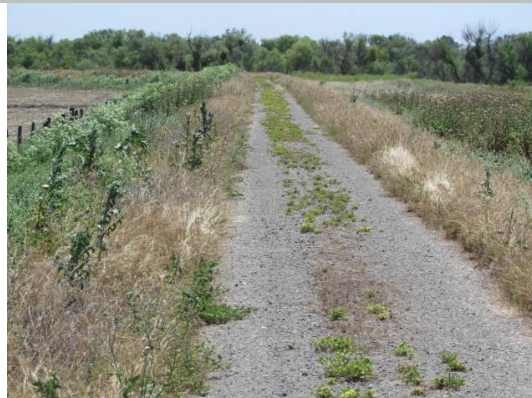
Photo 1 of 1 : FA_2016_NA0010_118_117_20161007_00021.jpg

LM Start	9.16	Rating **	M	Issue No.	117
LM End	9.78	Issue Type +	Ma	Location *	CR
Category	Earthen Levee			GPS Latitude/Longitude	
				Start	End
Item	Crown Surface / Depressions / Rutting			37.296145 °	37.293077 °
				-120.848588 °	-120.839170 °
DWR ID	DWR_NA0010_01_s_2012_117				
Comment Code					
C1 : Add appropriate material and re-grade the levee to bring the crown above the design elevation.					
Inspector Comment					
Control vegetation on levee crown.

Looking south at veg on levee crown.

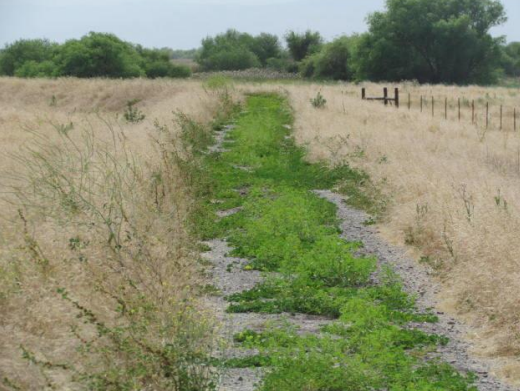
Photo 1 of 1 : FA_2016_NA0010_119_24_20161007_000006.jpg

Looking northeast at veg on levee crown.

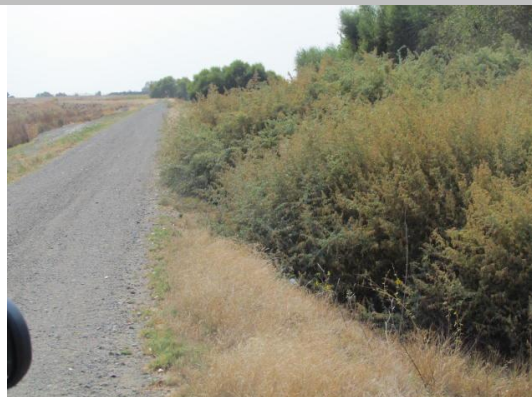
Photo 1 of 2 : FA_2016_NA0010_138_21_20161007_00008.jpg

LM Start	0.53	Rating **	U	Issue No.	21
LM End	0.53	Issue Type +	Ma	Location *	LS
Category	Earthen Levee			GPS Latitude/Longitude	
				Start	End
Item	Vegetation			37.213006 °	37.213006 °
				-120.698019 °	-120.698019 °
DWR ID	DWR_NA0010_22A_f _ 2014_21				
Comment Code					
V2 : Remove the wild growth other than native grasses from the levee slopes.					
Inspector Comment					
Dense vegetation on landward slope.

Looking at dense vegetation on landward slope. Fall 2015

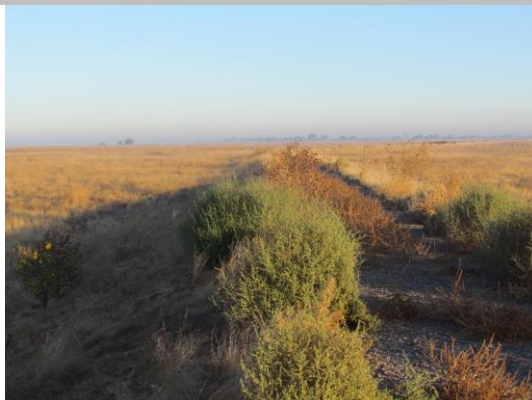
Photo 1 of 2 : FA_2016_NA0010_141_9_20161024_00023.jpg

LM Start	0.00	Rating **	U	Issue No.	9
LM End	2.49	Issue Type +	Ma	Location *	WS
Category	Earthen Levee			GPS Latitude/Longitude	
				Start	End
Item	Vegetation			37.296261°	37.271117°
				-120.880678°	-120.866599°
DWR ID	DWR_NA0010_25_f_2015_9				
Comment Code					
V2 : Remove the wild growth other than native grasses from the levee slopes.					
Inspector Comment

Looking at typical view of dense veg on waterward slope. (Fall 2016)
